# A-6 Intruder

# WALK AROUND

**By Lou Drendel**

**Walk Around Number 2  
squadron/signal publications**

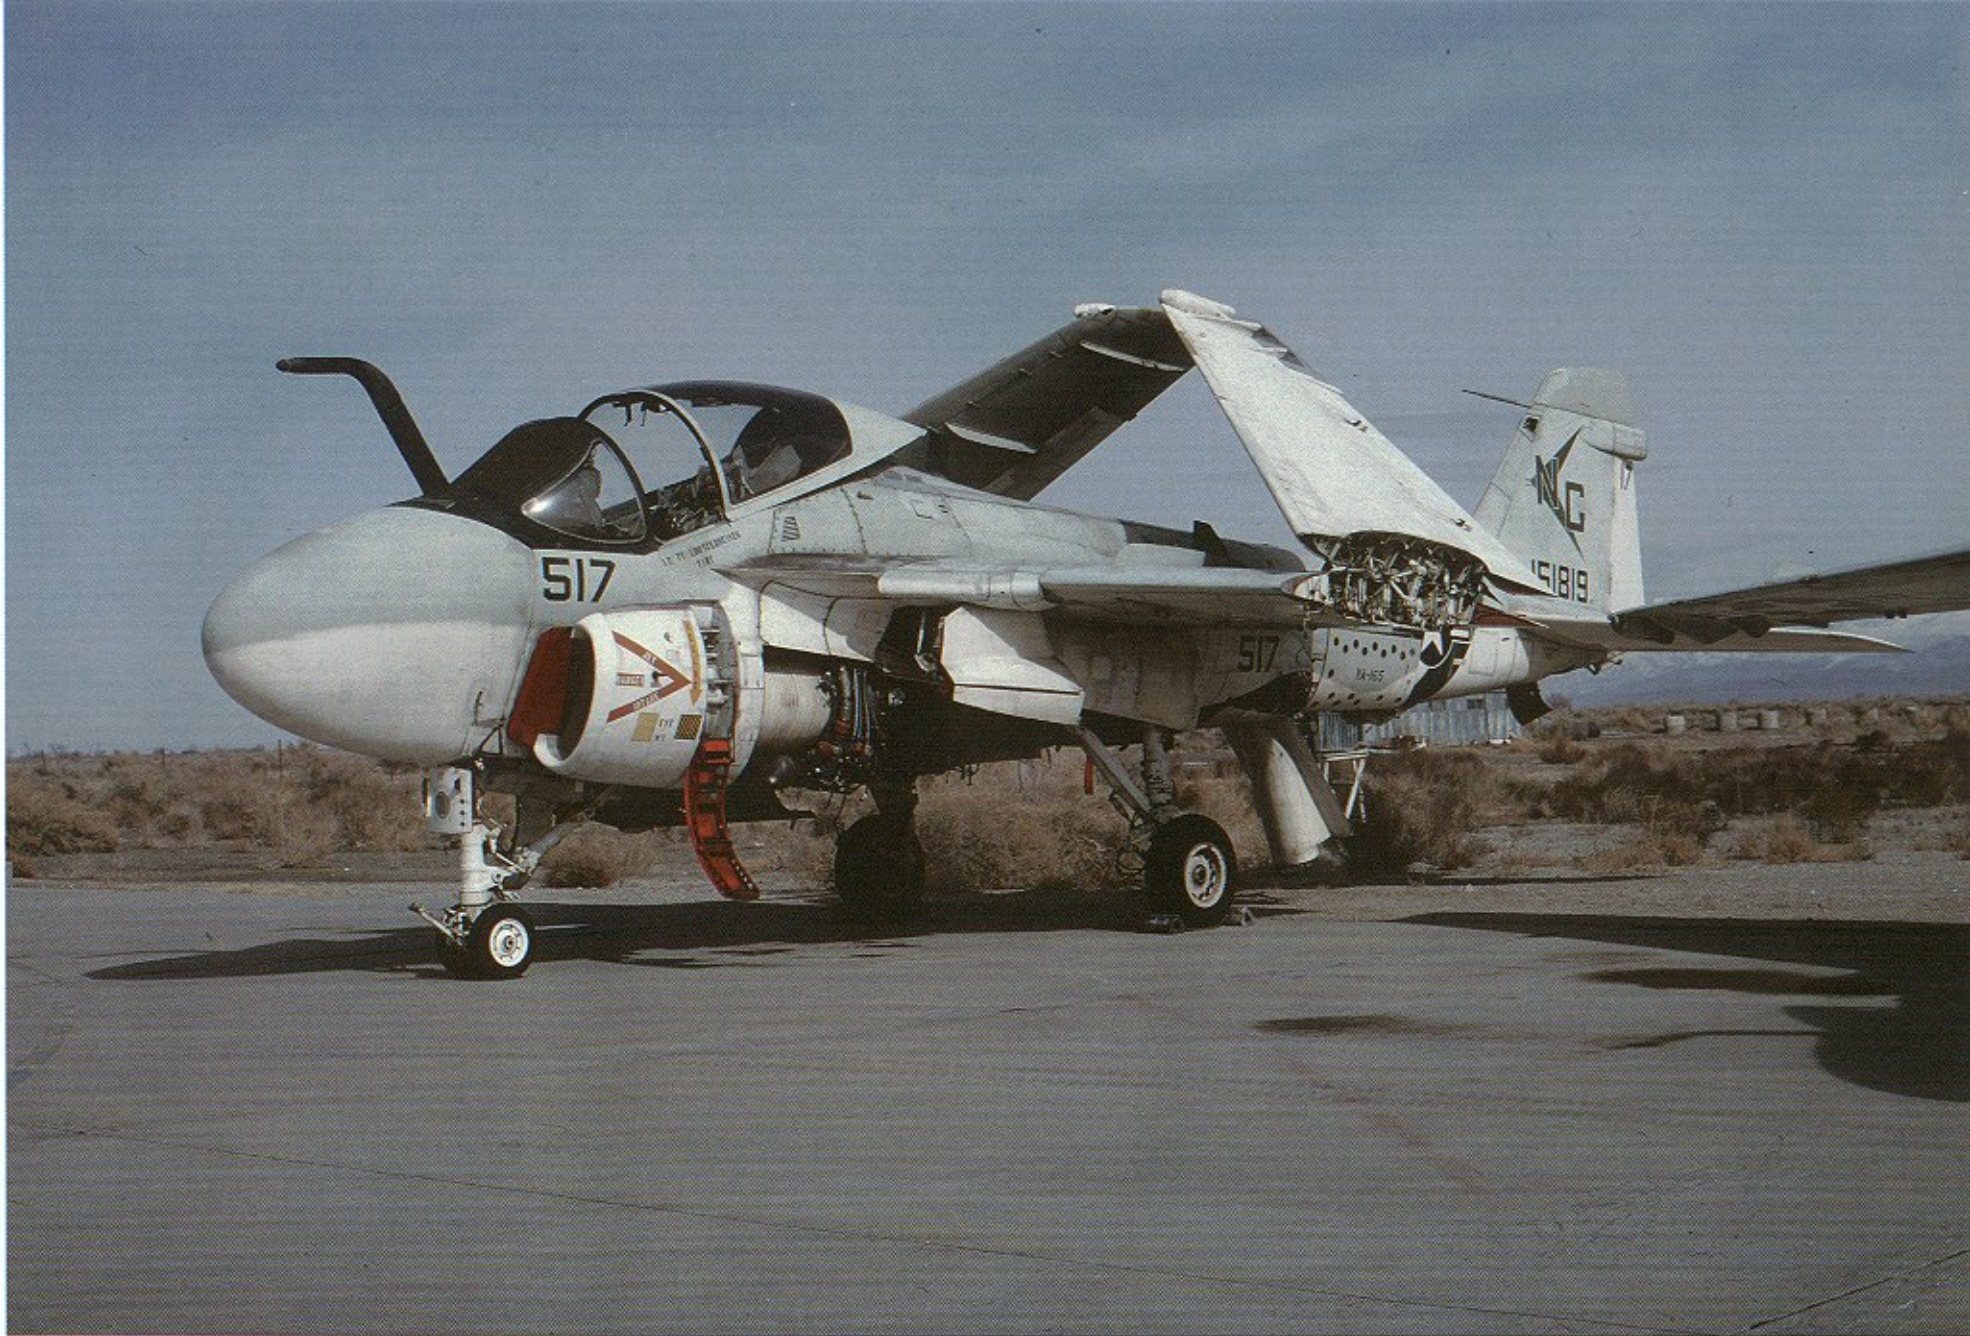
All KA-6s have been retired. Those not in storage at Davis Monthan AFB are used as maintenance trainers, such as this example at NAS Fallon, BuNo 151819, formerly of VA-165. A number of interesting items are visible, including detail of the wing fold area, lowered refueling hose housing, boarding ladder and fuselage speed brake. The open panels on the fuselage are part of the engine access area.

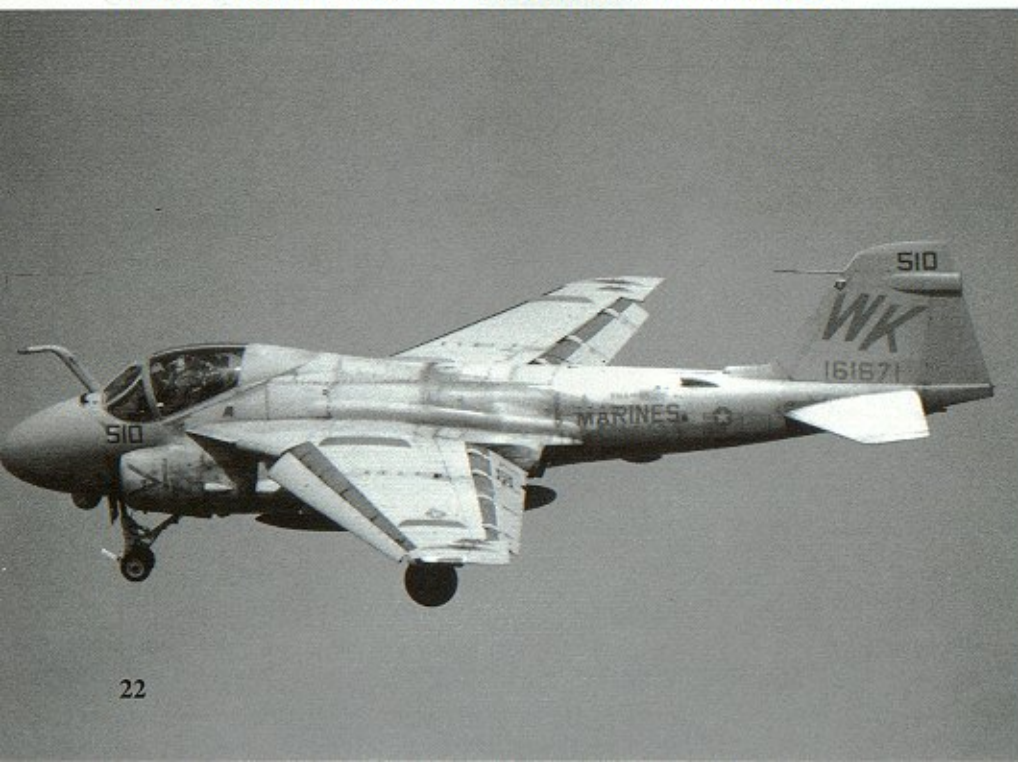
The bulge in the center of the wing is the wingfold mechanism cover fairing. This is one of the composite-winged A-6Es.

Also visible on the wing uppersurface, besides the wingfold mechanism fairing, are the flap actuator covers and ECM fairing just behind the outboard wing fence and the fuel dump outlet, which is below the ECM fairing.

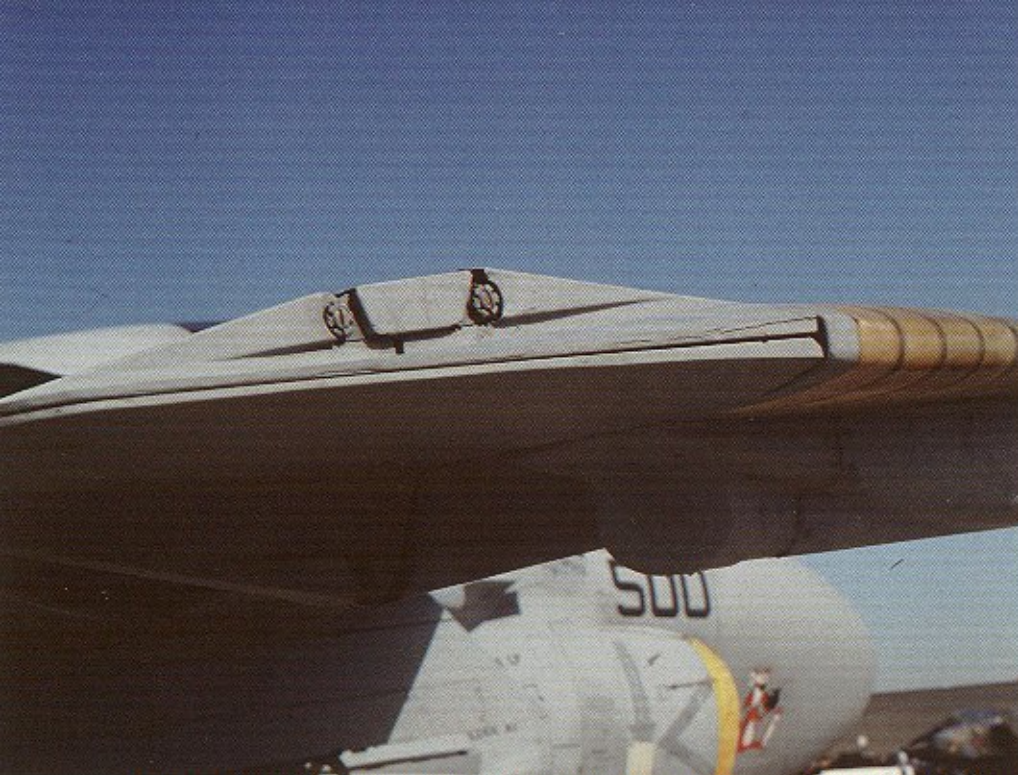
There is a speed brake mounted on each wingtip. The actuators are covered with aerodynamic fairings on both the top and bottom of the speed brake. These are very effective in slowing the aircraft and are used routinely during landing approaches. Outboard of the speed brake is a low intensity strip formation light.

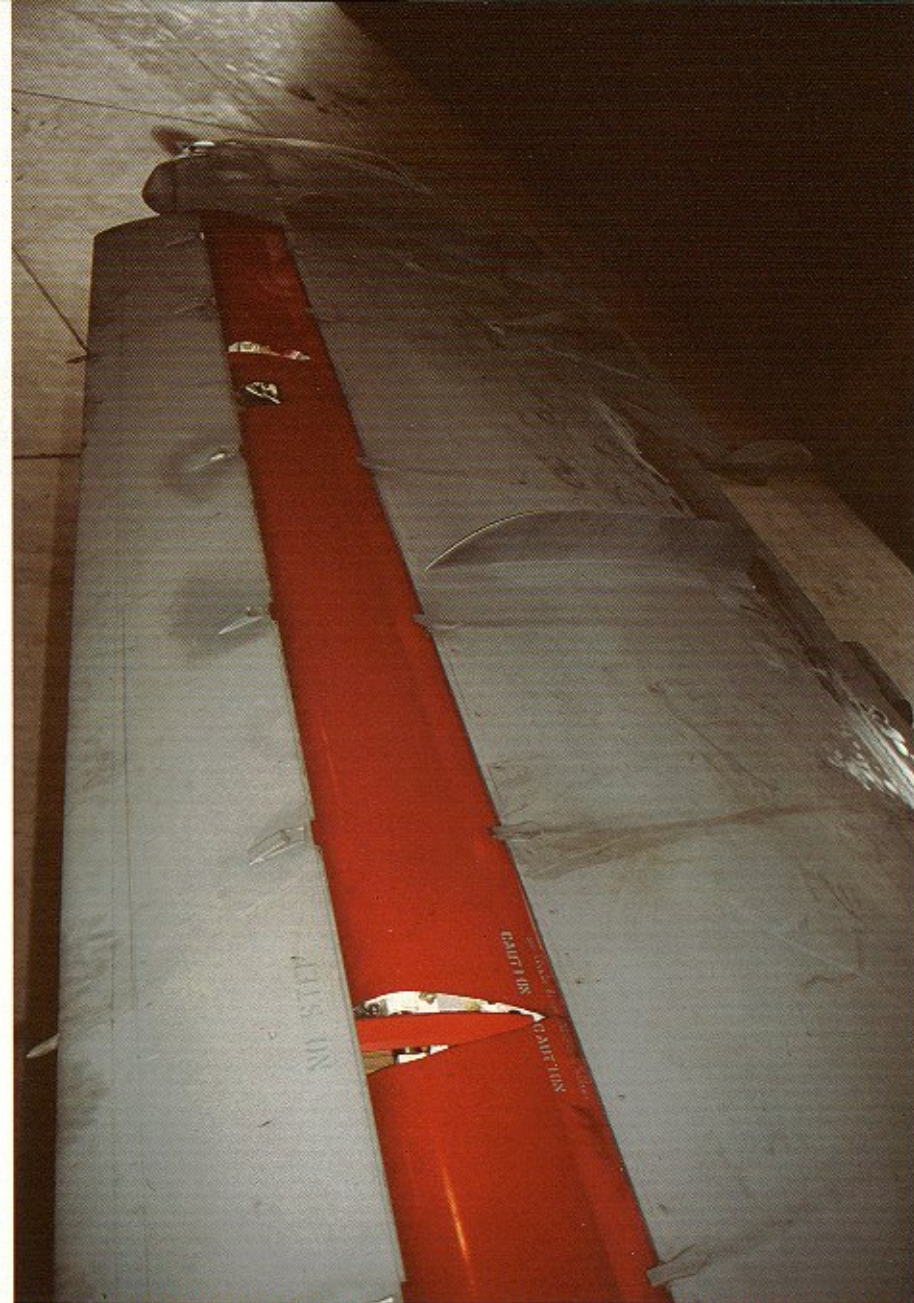
The wing leading edge slat in the fully extended position. The slat is controlled by two actuators visible in the White areas. Also above each actuator are White "Caution" warning legends.

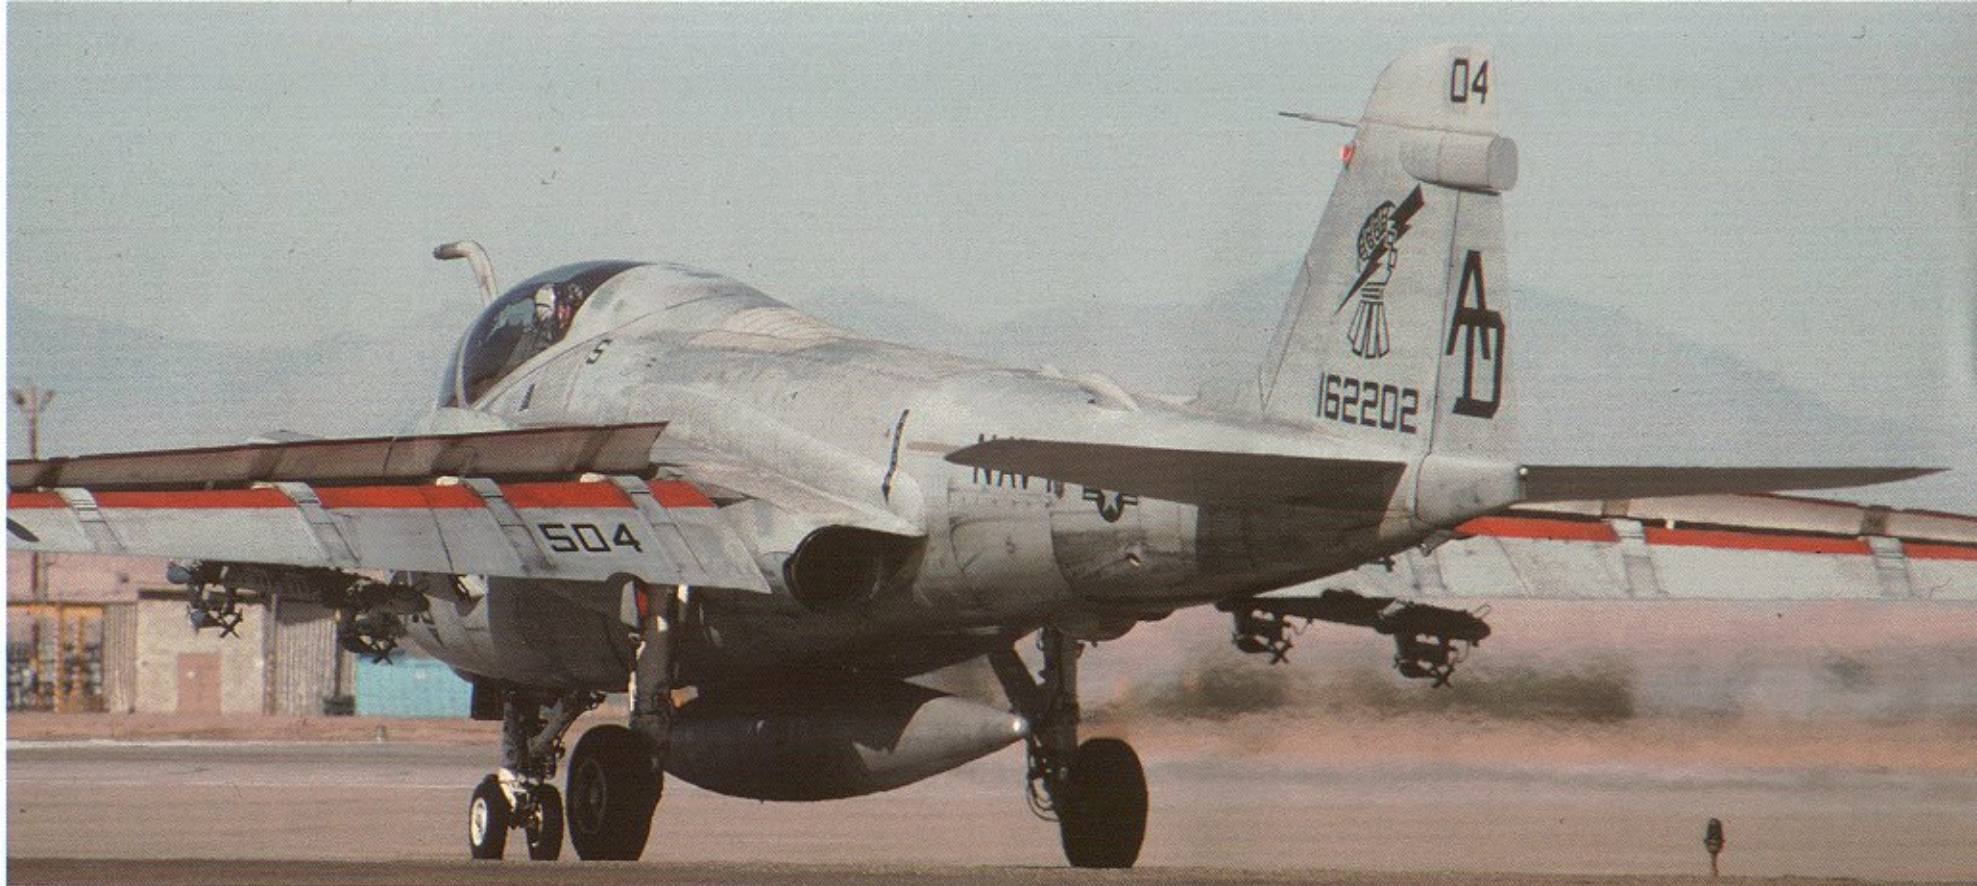
This A-6E has the upper wing spoilers and trailing edge flaps fully extended. The spoilers are immediately forward of the full span trailing edge flaps on the upper surface of the wing. The spoilers are used to dump lift and enhance braking effectiveness on landing rollout. The aircraft is also carrying Multiple Ejector Racks (MERs) on the inboard underwing pylons. The MERs are configured with Blue twenty-five pound practice bombs.

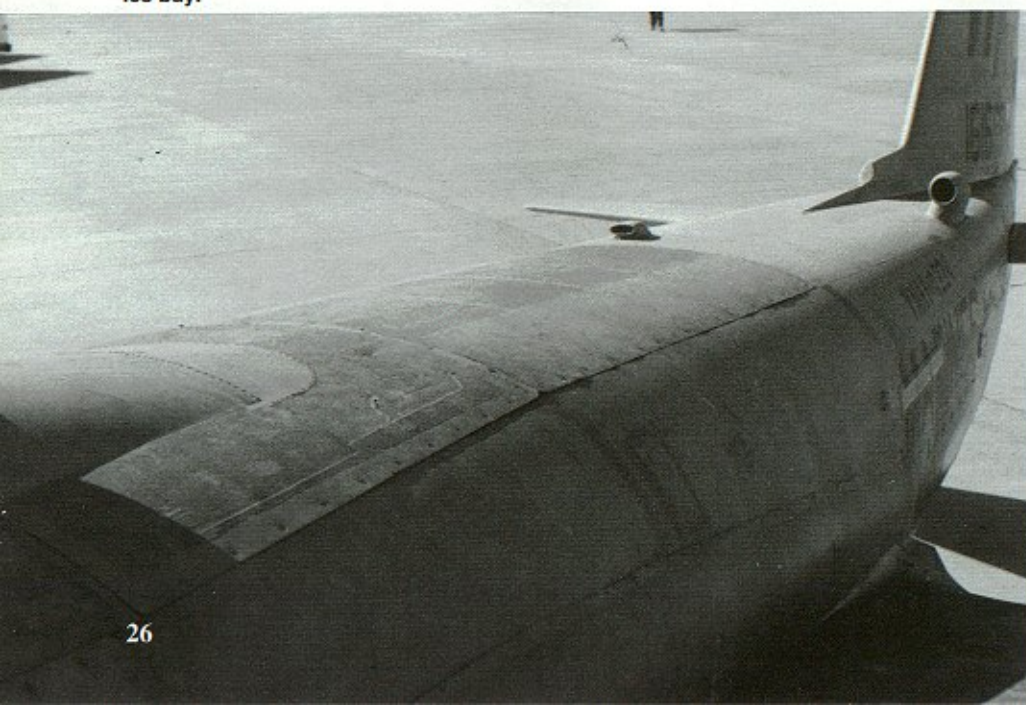
The emergency Ram Air Turbine (RAT) is extended from the rear of the port wing root to provide emergency electrical power in case of an engine failure.

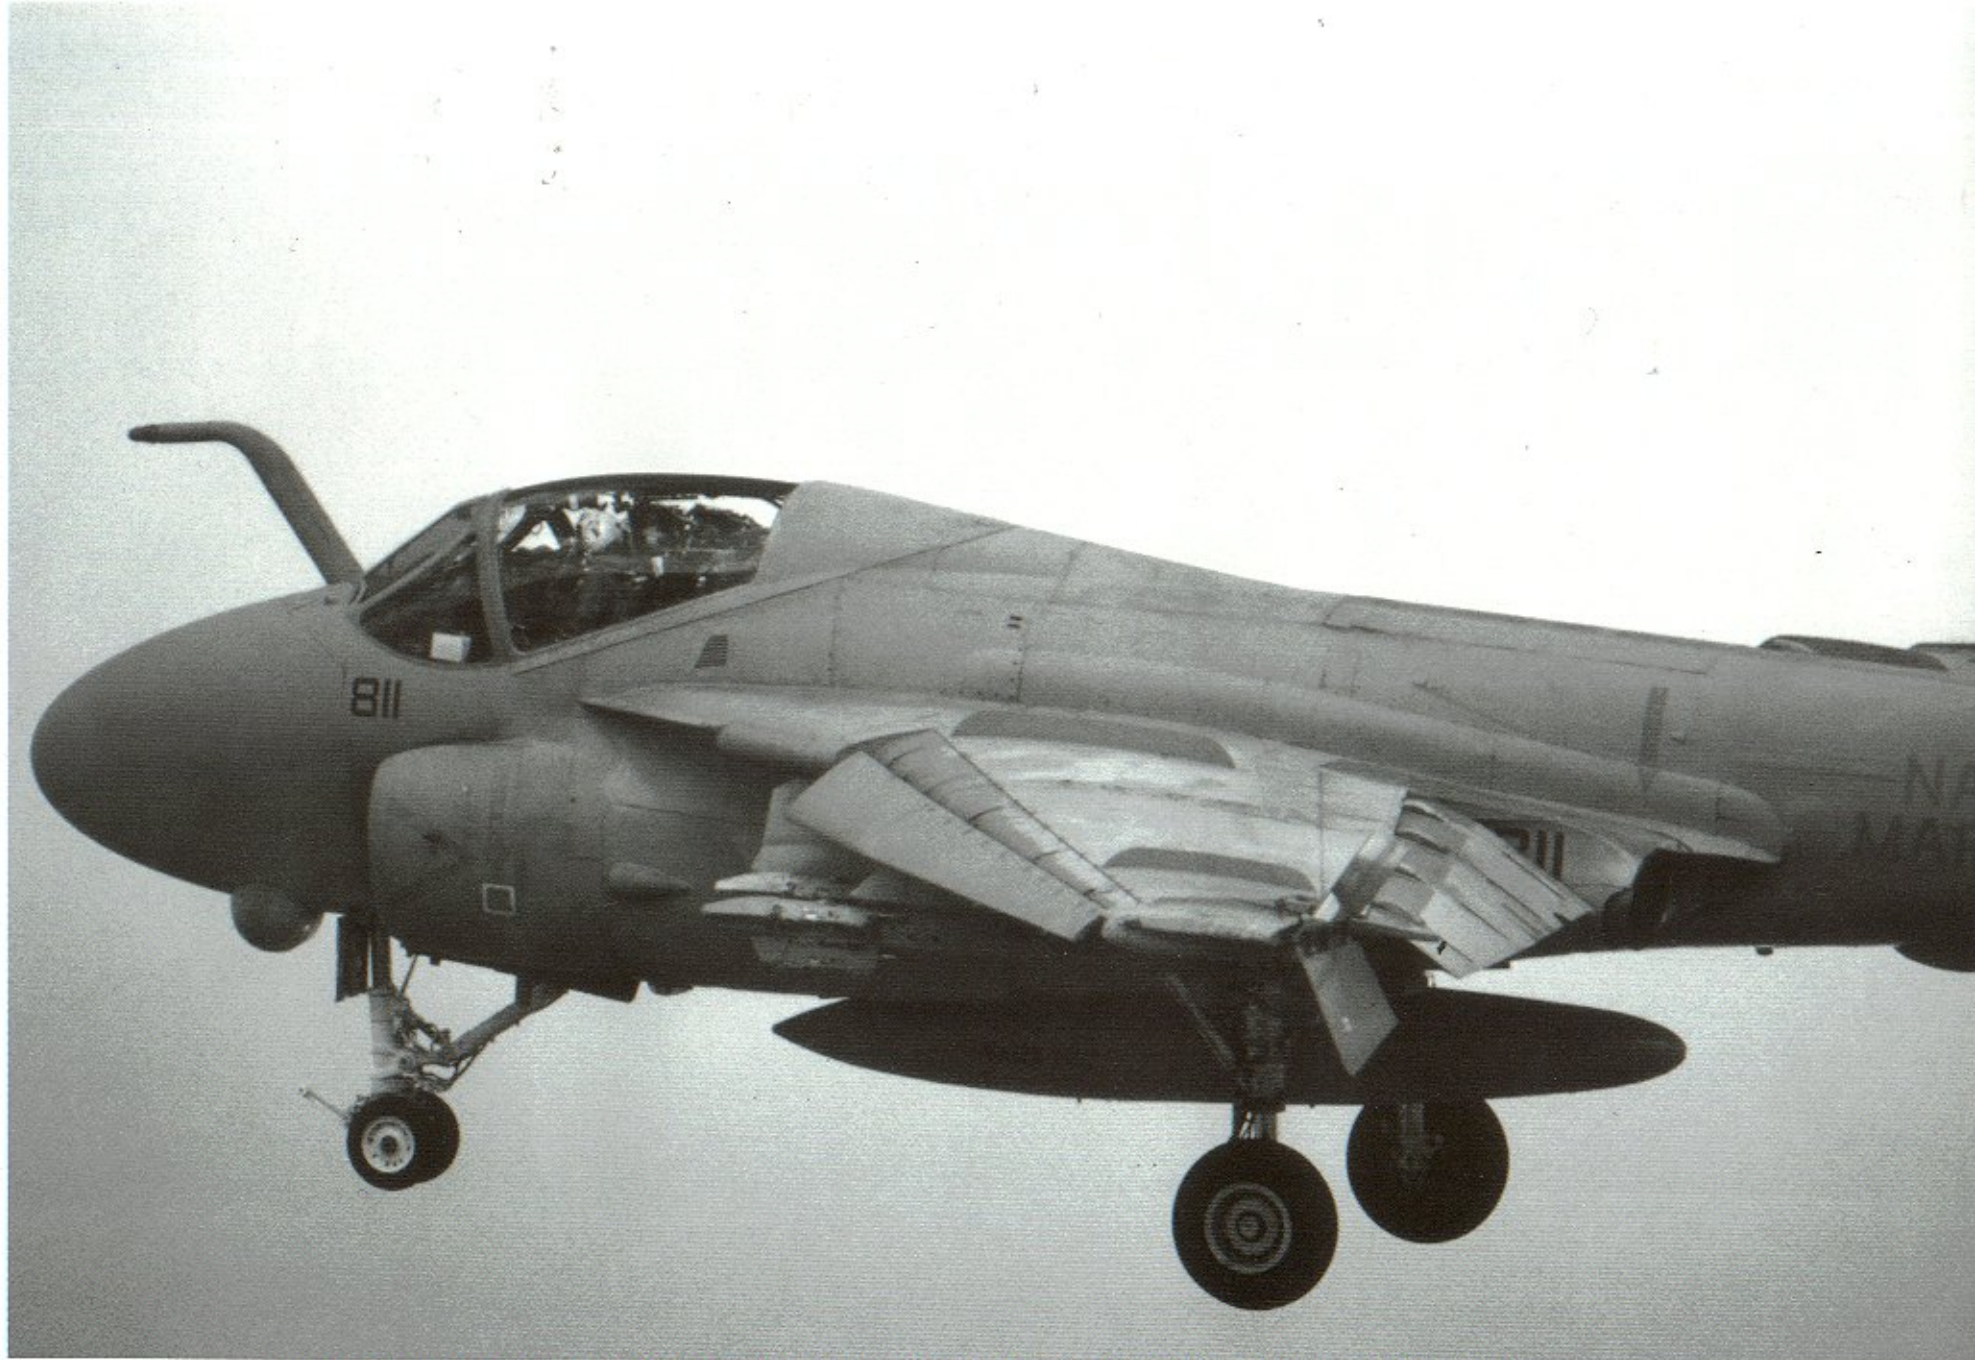
An A-6E (BuNo 155637, NJ 811) of VA-128 on final approach for landing at MCAS El Toro, California on 22 April 1988. The wingtip speed brakes are fully deployed to allow the pilot to keep the engines spooled up at higher power settings in case he needs to make a missed approach and go around. The interiors of the leading edge slat, speed brakes and flaps are in Red. The landing gear legs are fully extended with their oleo pistons at the full travel position.

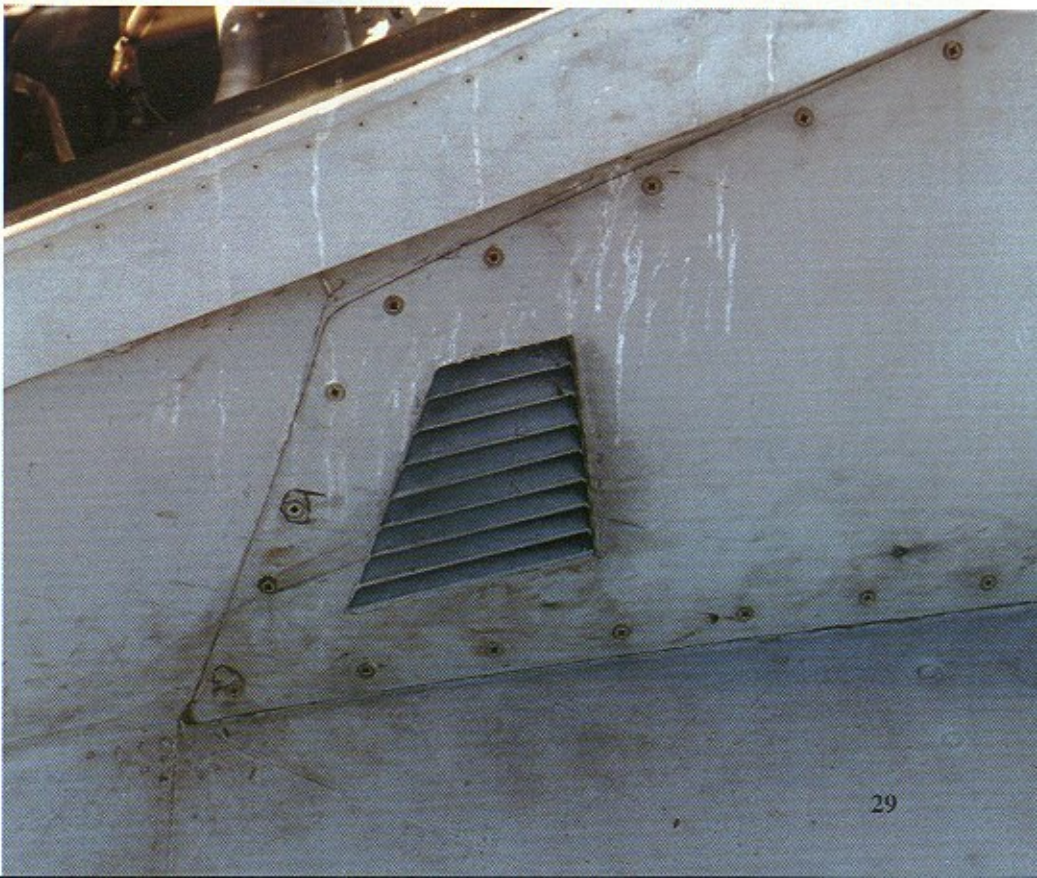
The cooling air spill vent is located under the canopy rail on the port side of the aircraft.

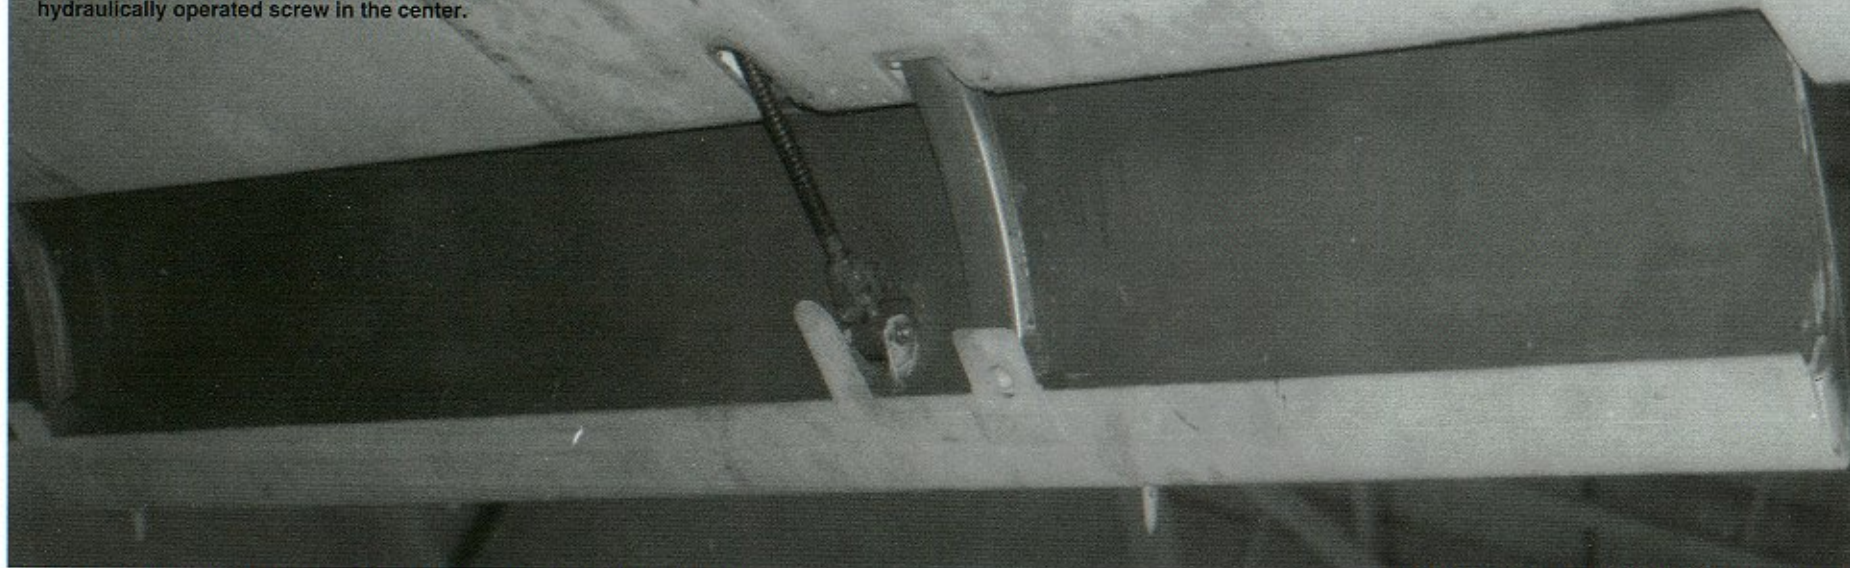
The outboard main landing gear door actuator mechanism. The hydraulic piston on the actuator is extended. All gear door operating parts and the interior of the doors themselves are painted Gloss White to show fluid leaks. The door edges are in Red.

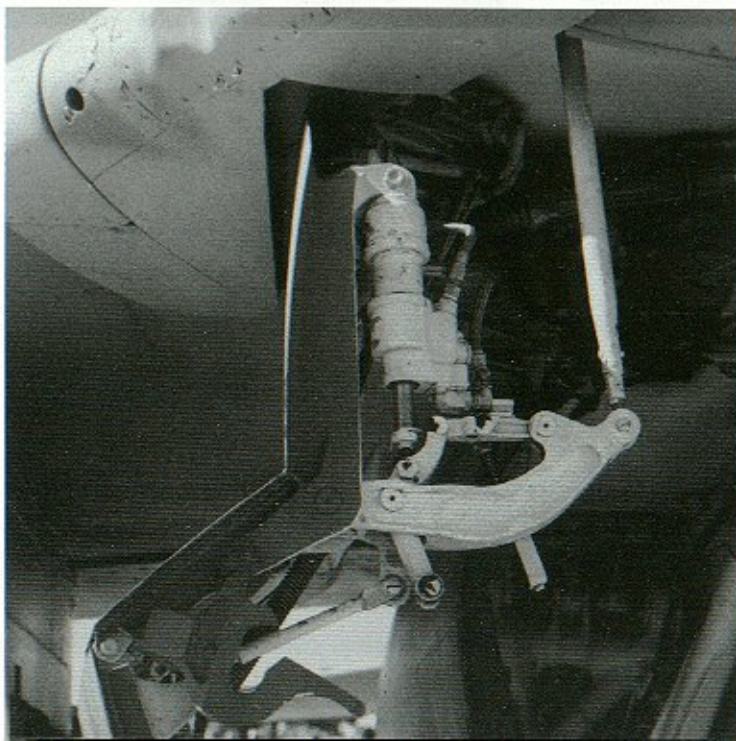
Visible at the forward edge of the landing gear well is the air conditioning system exhaust fairing, which is stainless steel. The fairing is made of steel because it can get extremely hot.

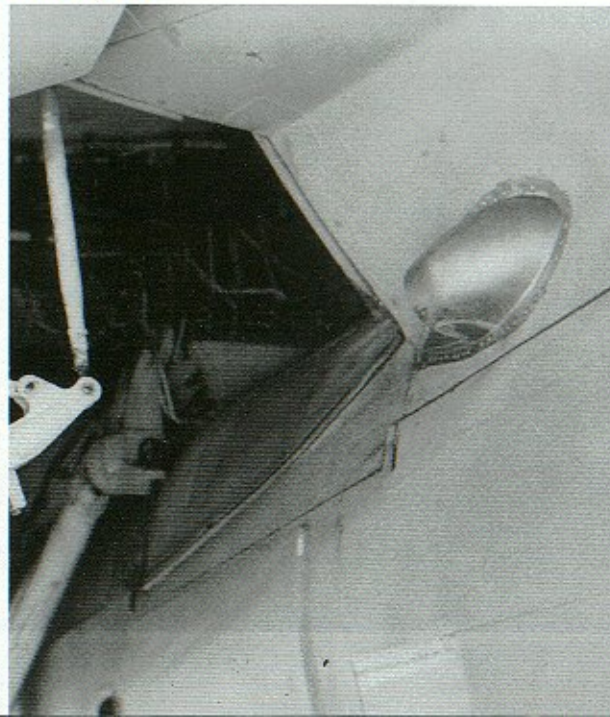
The outboard main landing gear door (port side) viewed from above. One of the required items to check on a preflight check is the condition of the hydraulic lines running to the door actuators.

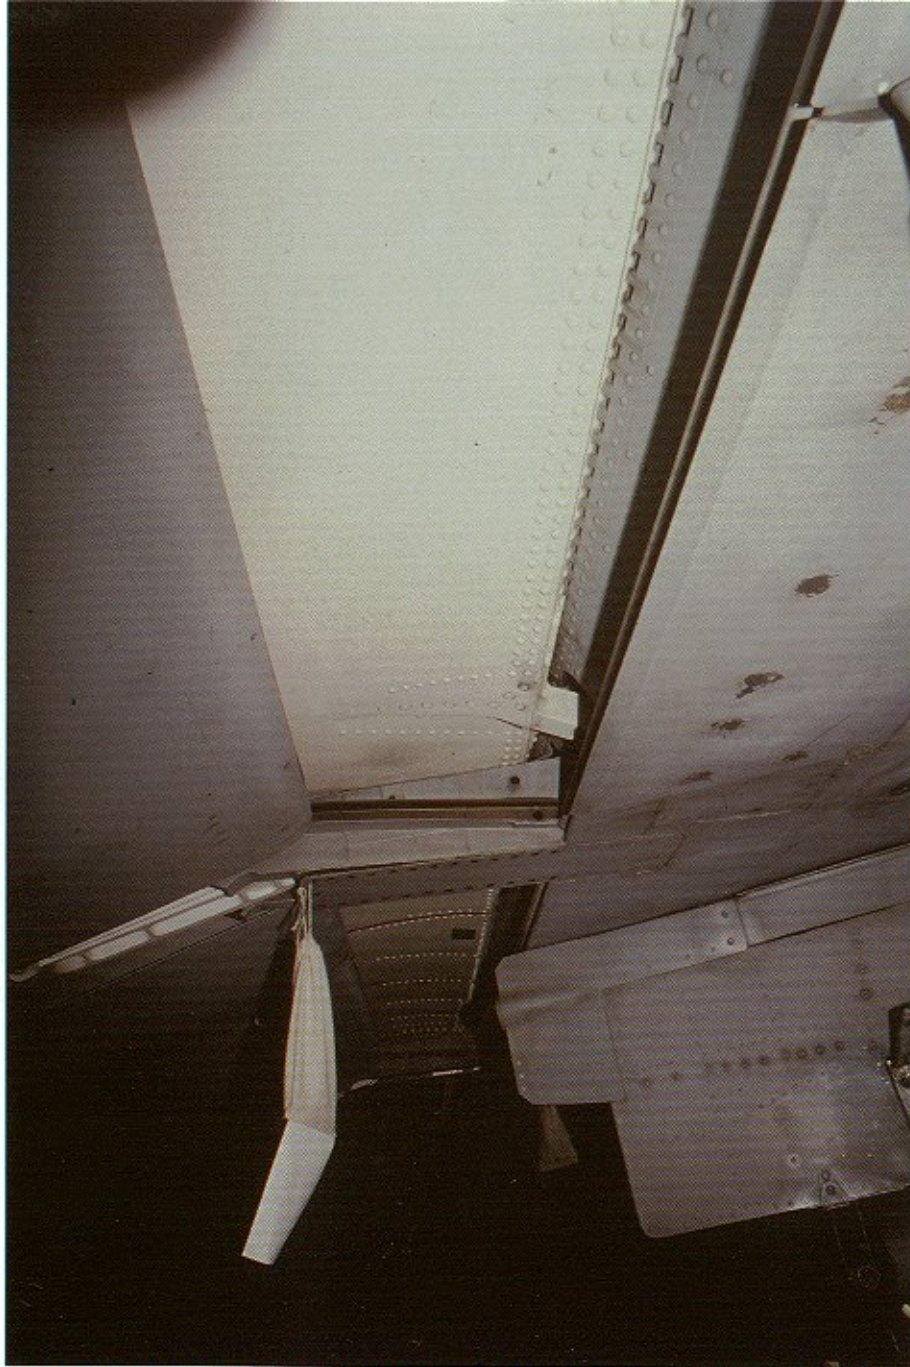
The trailing edge flaps can be extended some twenty degrees for landings and takeoffs. The object in the foreground is the flap actuator/guide. Also visible is the trailing edge of one of the underwing ordnance pylons.

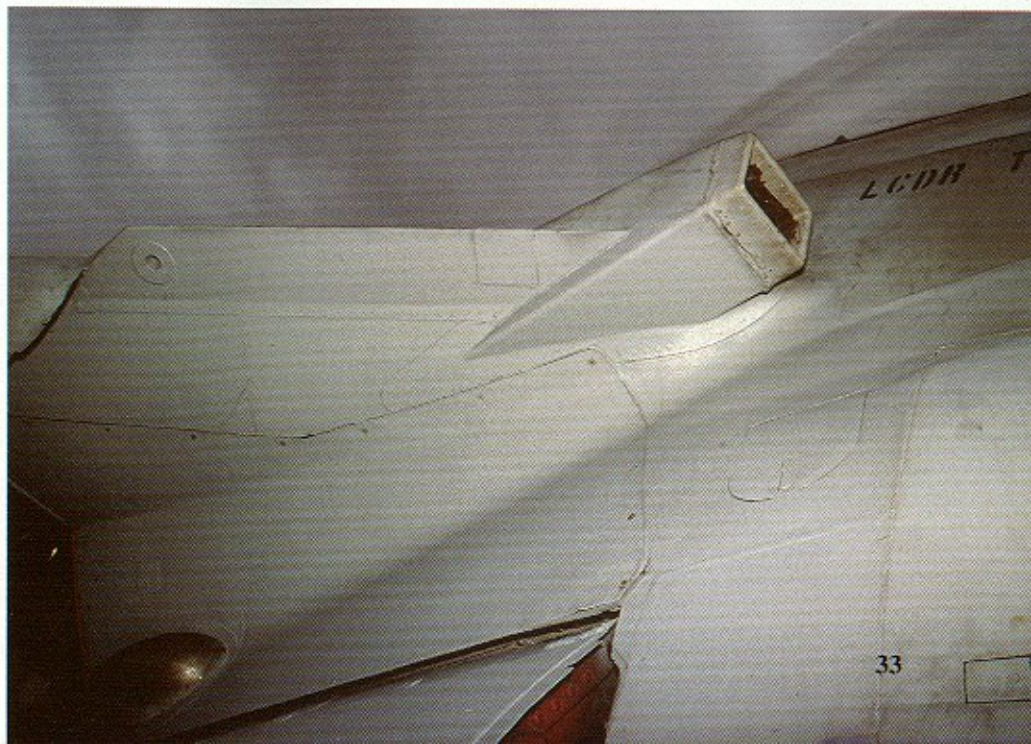
The large intake on the starboard wing root is for the aircraft's air conditioning system. Next to it is the starboard wing stall warning buffet strip. The bright fairing at the bottom is the air conditioning air exhaust port.

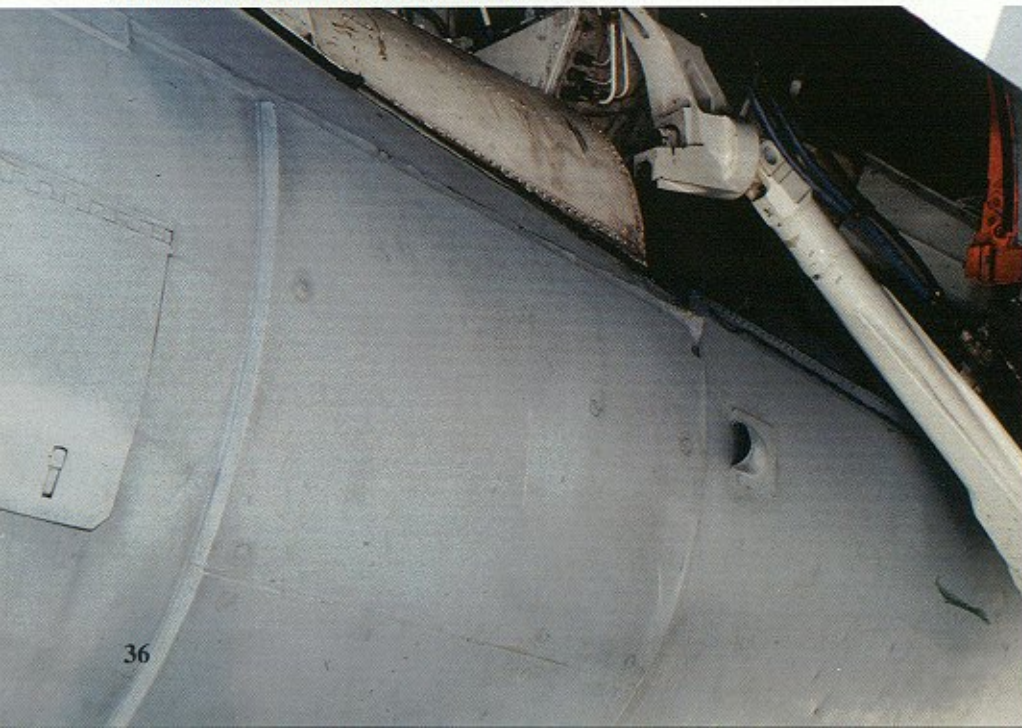
Late production A-6E TRAMs were fitted with a rearward facing Electronic Countermeasures (ECM) antenna and fairing on each wing above the fuel dump vent. These ECM fairings were originally developed for the A-6F program.

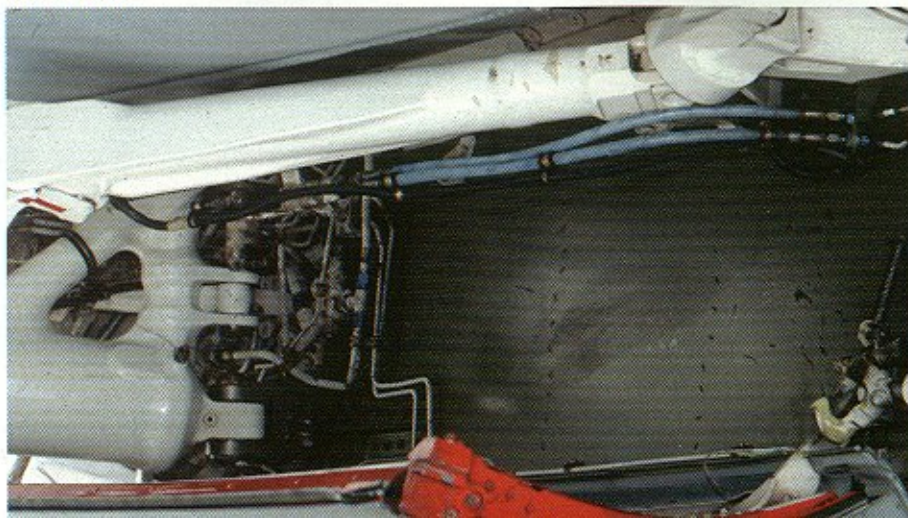
The starboard main landing gear wheel well door, looking forward. The door retraction arm is in the center, along with the retraction system hydraulic actuator.

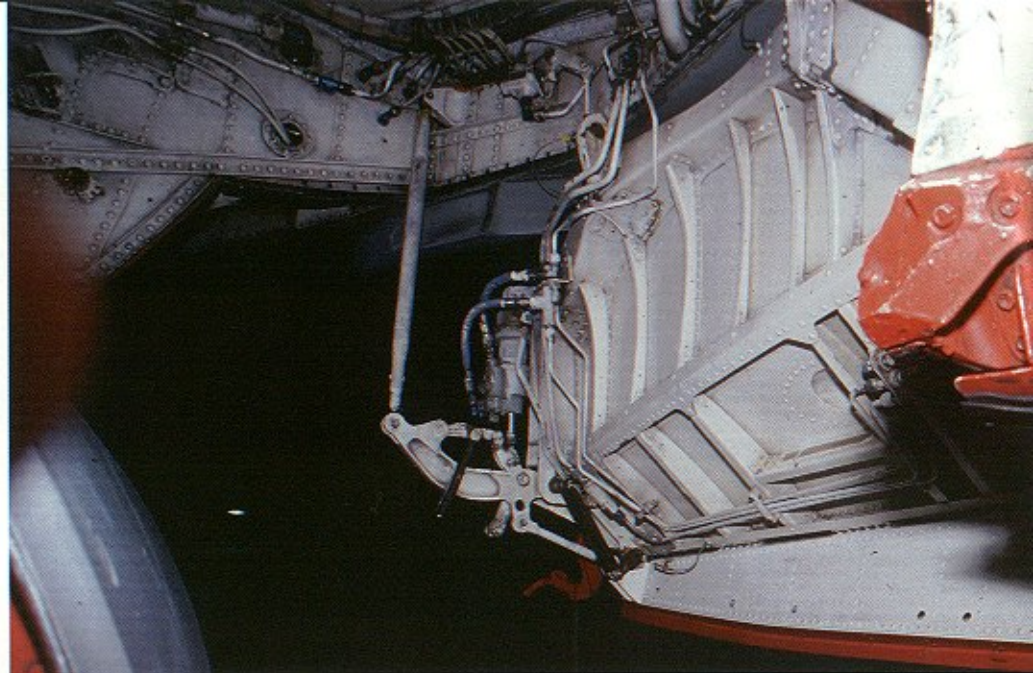
Main landing gear strut with the aircraft tie-down chains attached to the tie down attachment points. Each wheel strut, mains and nose, have these tie down points.

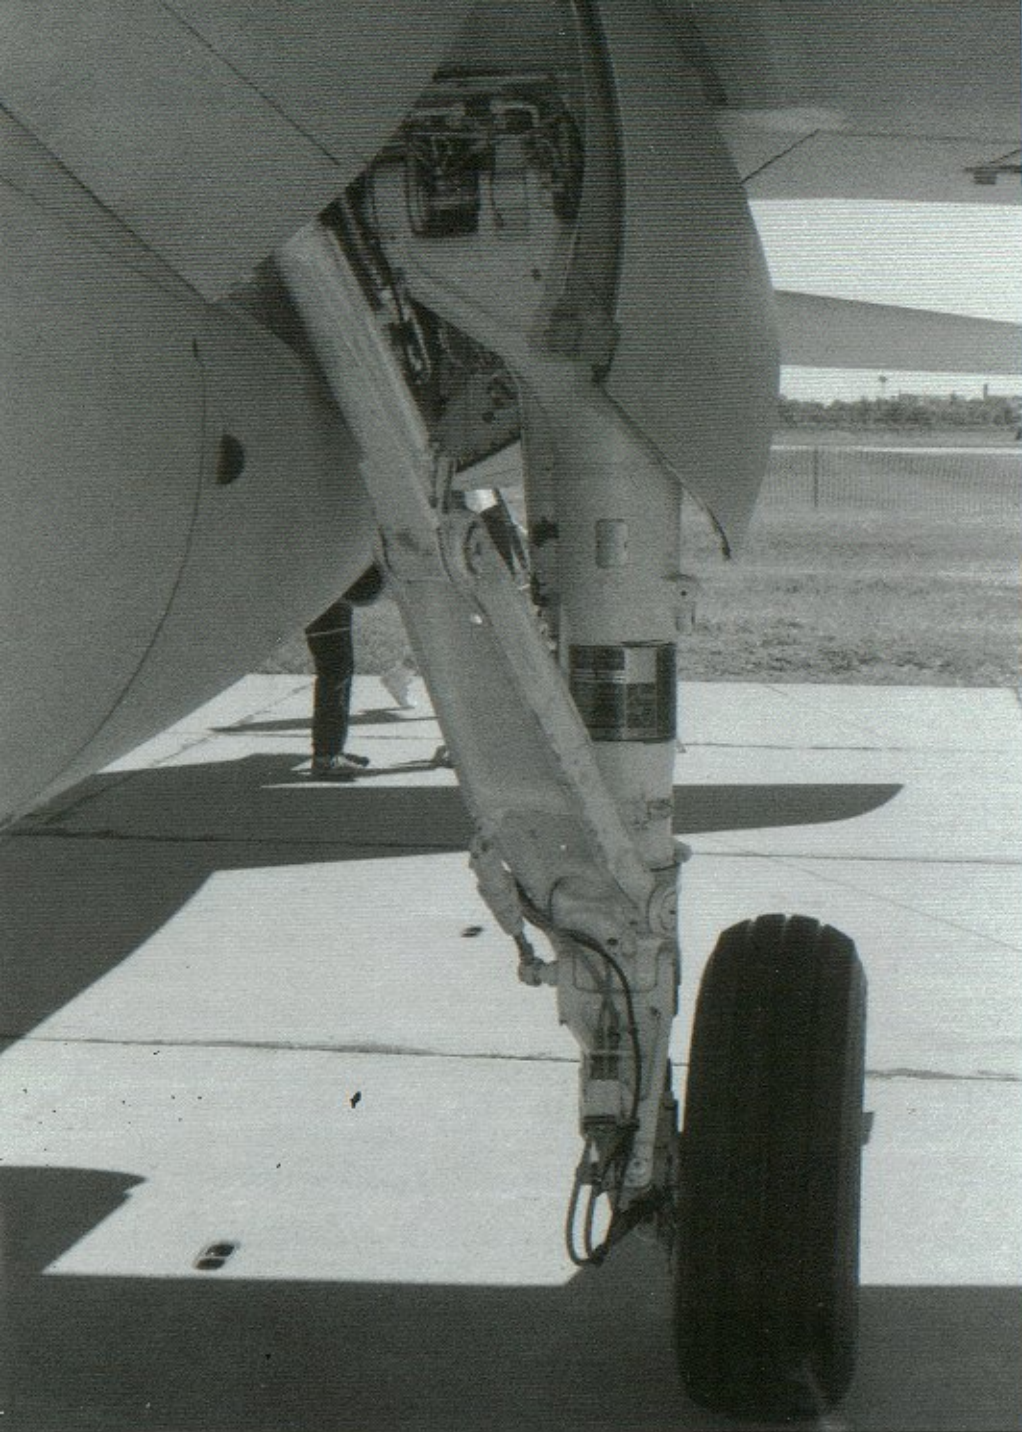
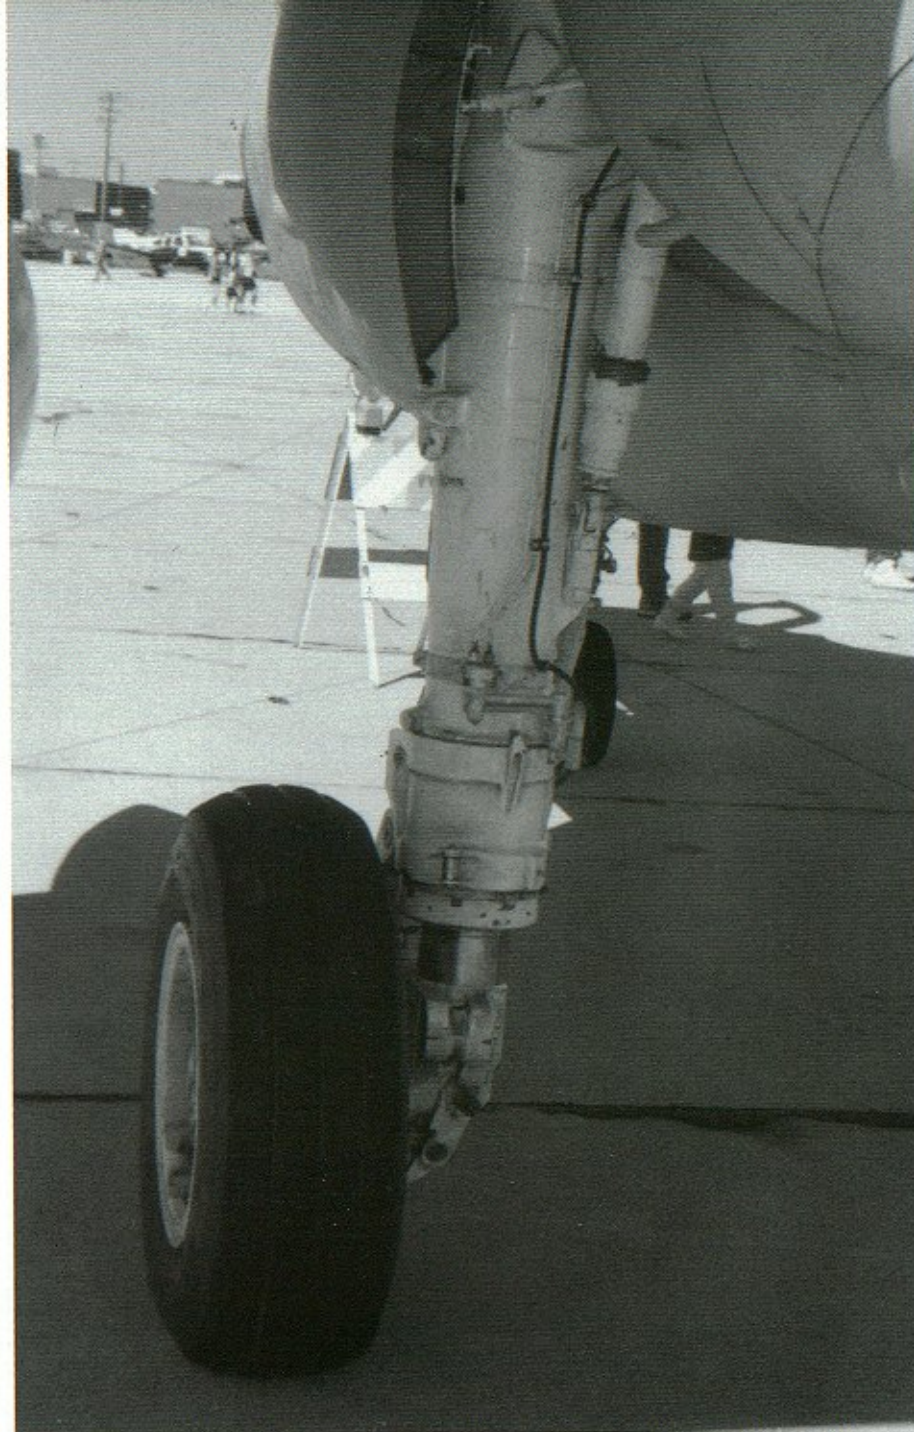
This is the port main landing gear leg of an EA-6B. It is identical to the landing gear used on other variants of the A-6 series. The data plate on the main strut provides maintenance personnel the information such as the part serial number, when the strut was made, oleo pressures, and other valuable information.

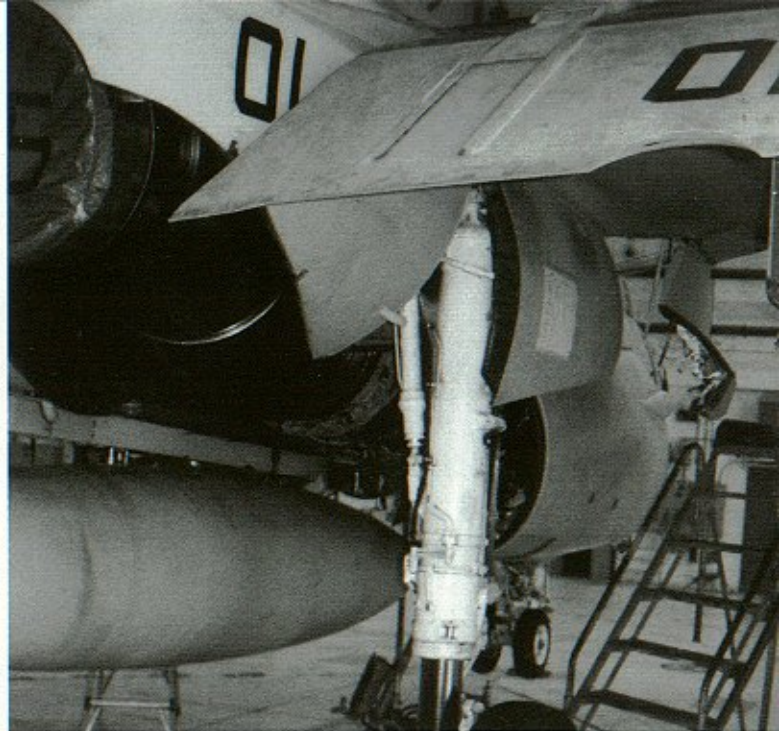
The wing flap cut out is to accommodate the underwing tank. It was discovered that when the flaps were lowered they struck the wing tank. The cut out prevents this from happening.

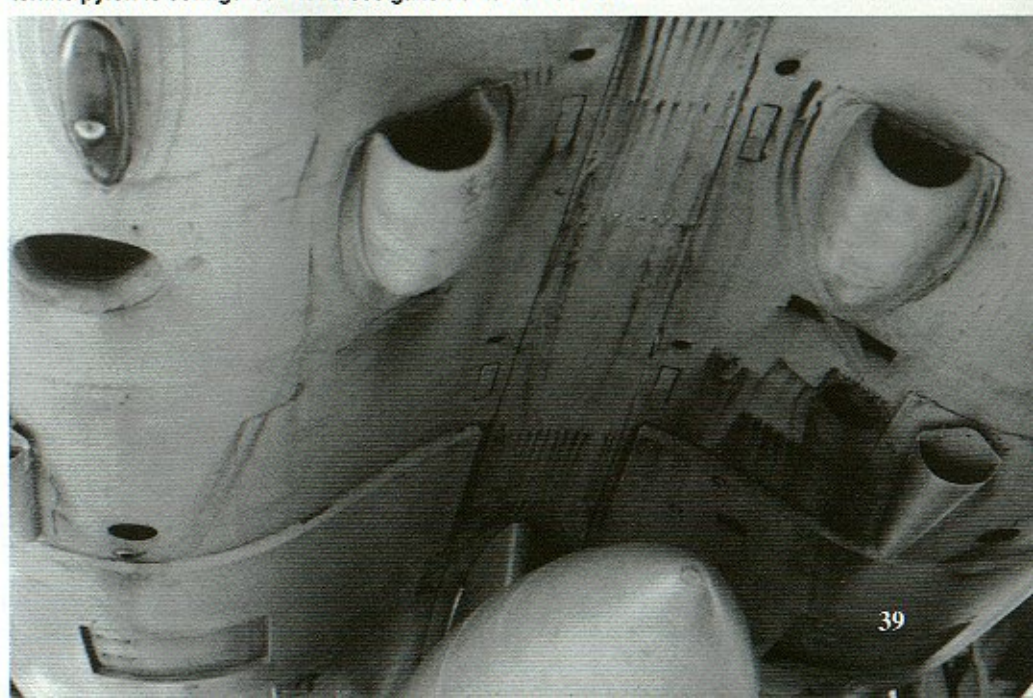
Looking back along the fuselage underside from the nose wheel well, there are a number of vents, engine compartment cooling air scoops, and a Red anti-collision light. The centerline pylon is configured with a 300 gallon external fuel tank.
